New York State Department of Transportation

Yellow Flag NB22CTW020

BIN: 1065318

Location: Span 230, Girder G19 at Pier 229.

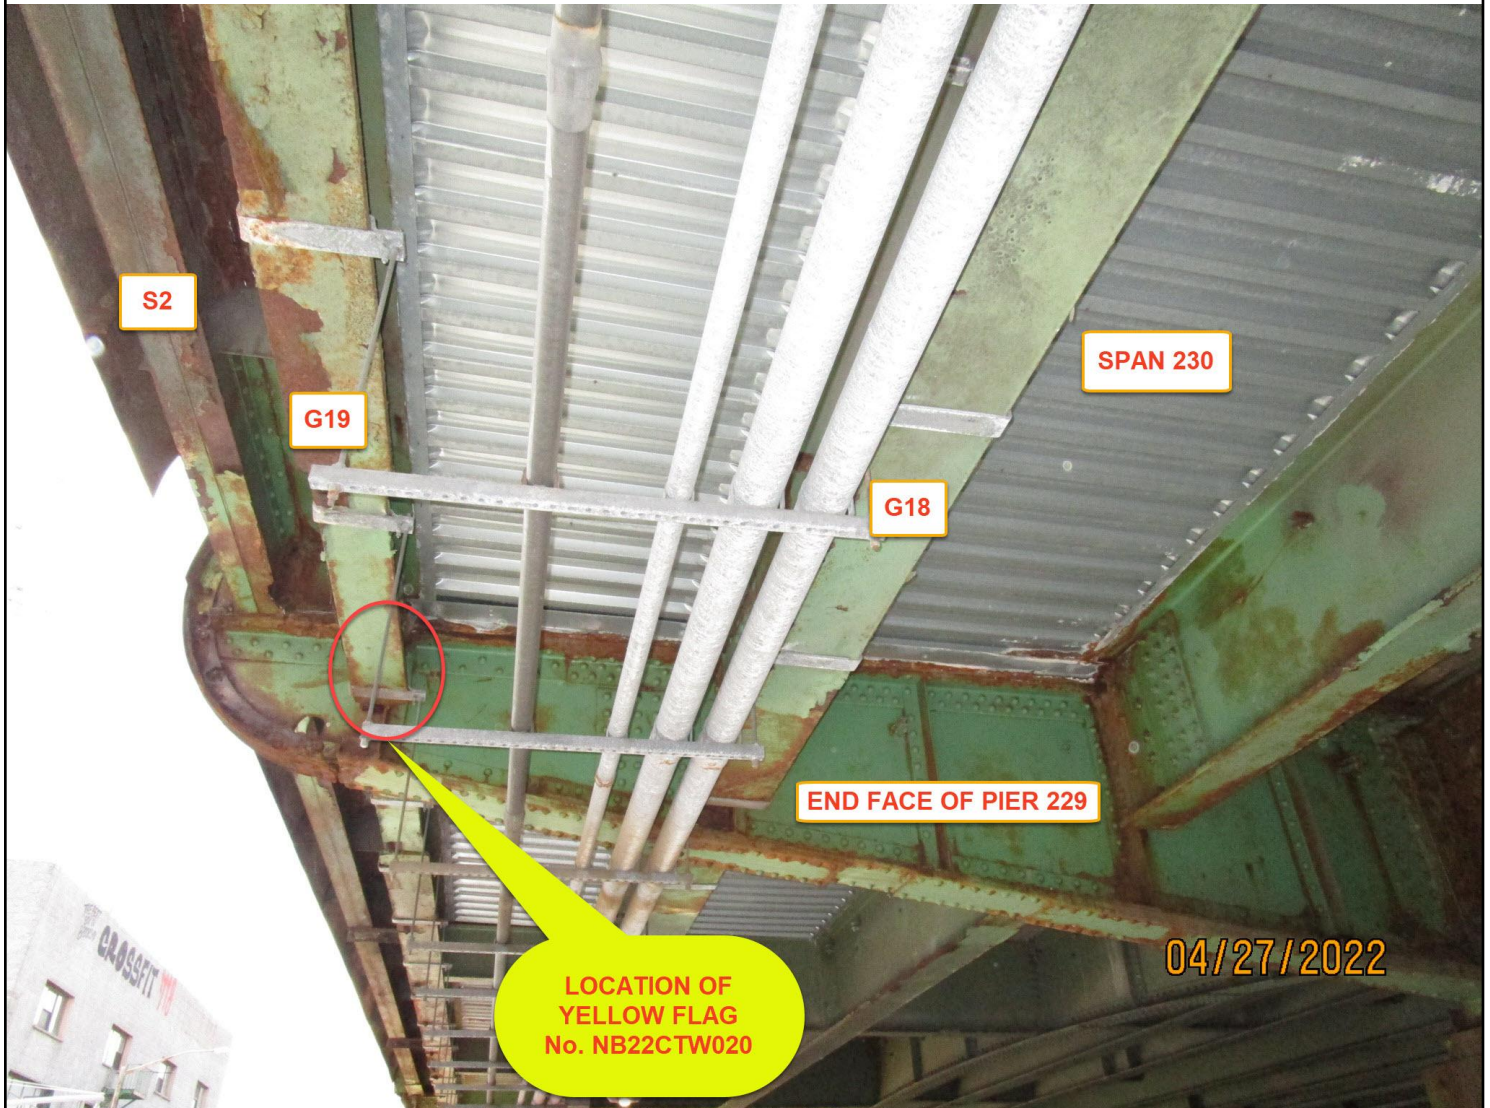
Photo Number: 1

Attachment Description: Span 230, Girder G19 at Pier 229: General View of Framing at Flagged Location. Looking Begin.

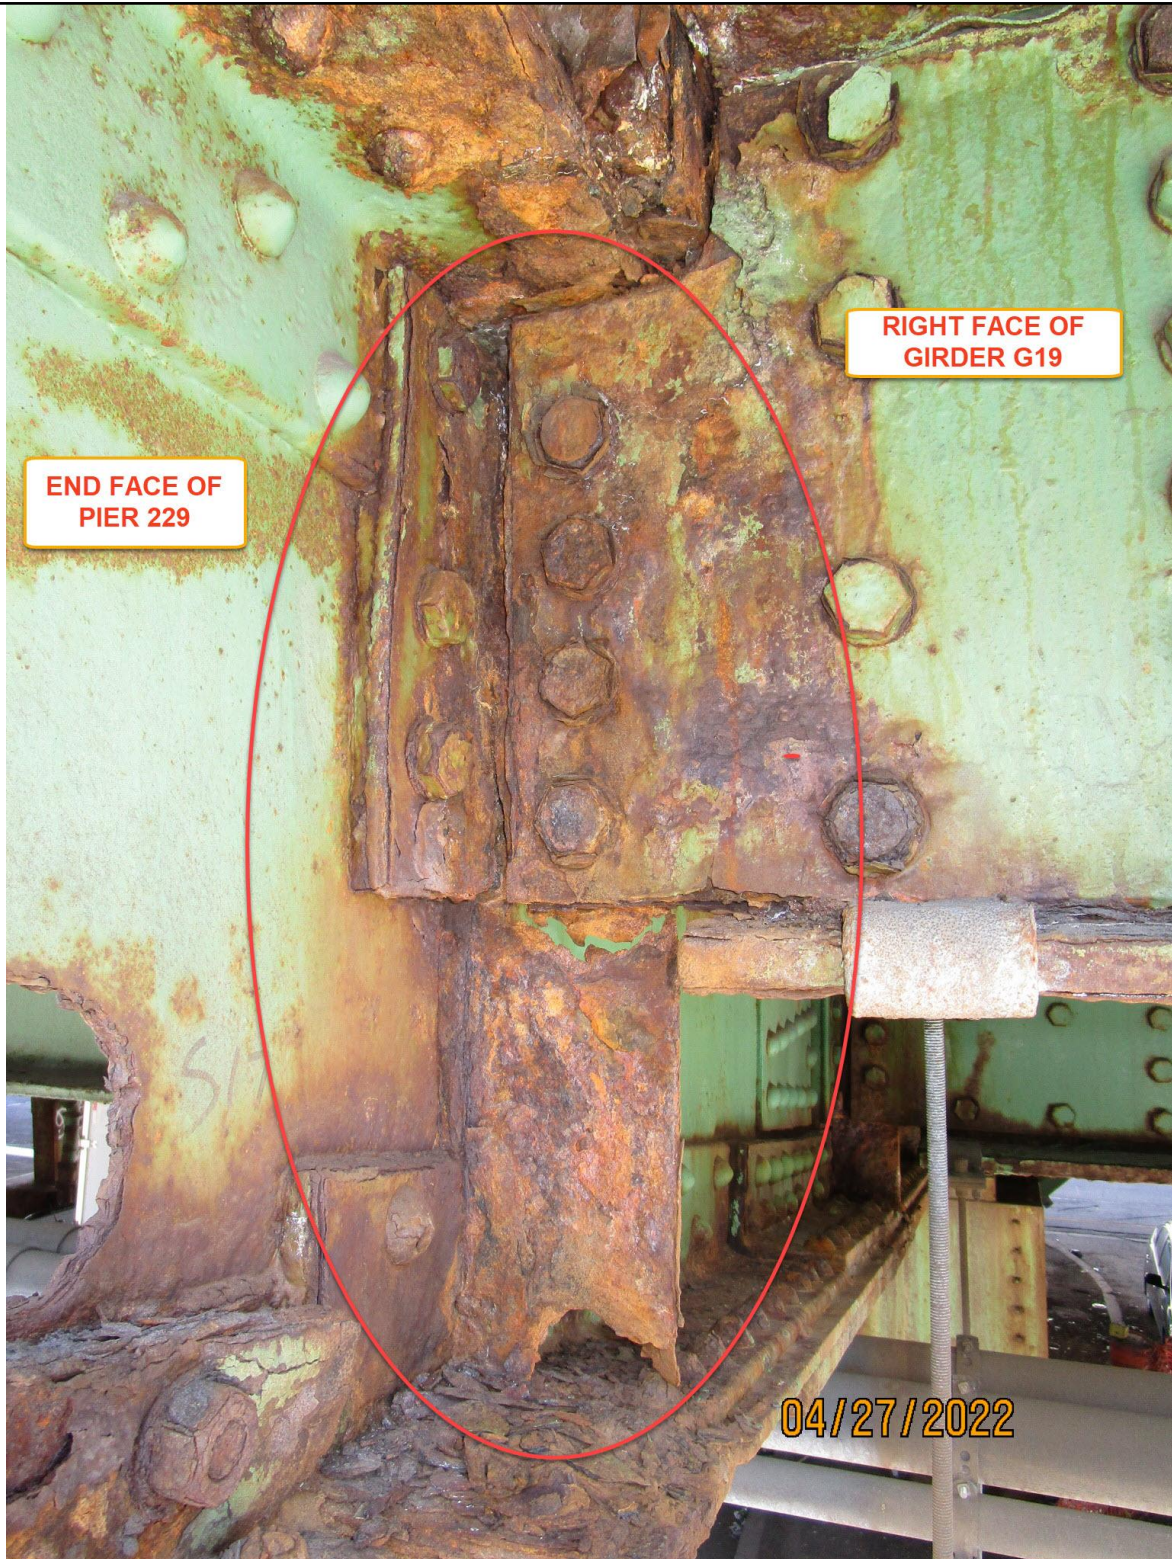
Photo Number: 2

Attachment Description: Span 230, Girder G19 at Pier 229: General view of flag location. Looking Begin Left.

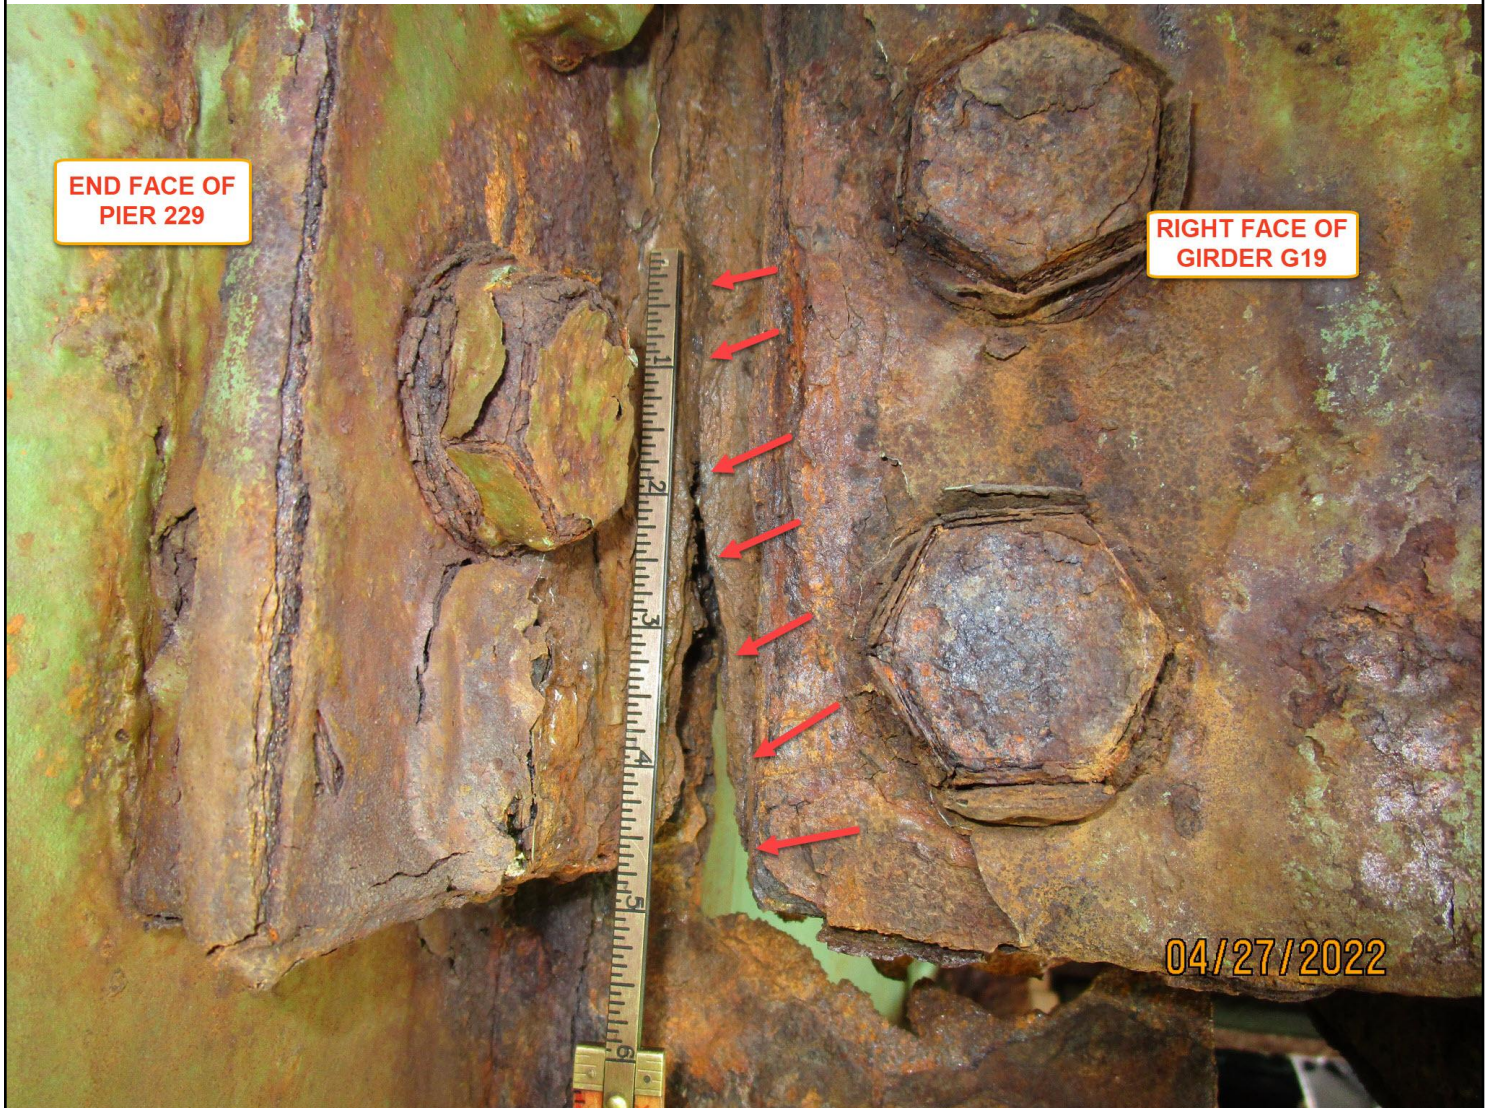
Photo Number: 3

Description: The right side connection angle at Girder G19 connection to the pier cap at Pier 229 exhibits a 4-3/4" (previously 3-1/2") long vertical corrosion crack x 1/2" wide (no change) at the lower fillet section. The upper fillet section has a 5" long (previously 2") vertical corrosion crack x 1/4" wide (previously 1/8"). In addition, the vertical stiffener connection angle is heavily corroded and exhibits a 3-1/2"W x 2-1/2"H (previously 3-1/4"W x 2-1/2"H) corrosion hole at the base and a 4"W x 3"H L-shaped corrosion hole (no change) with a 1-1/2" long corrosion crack (not previously noted) adjacent to the lower cope of G19 with 50% section loss in the surrounding area.

Attachment Description: Span 230, Girder G19 at Pier 229: A vertical corrosion crack measuring 4-3/4"L x 1/2"W is located in the lower section of the right connection angle and 4"W x 3"H L-shaped corrosion hole in the left vertical stiffener connection angle. Looking Left.

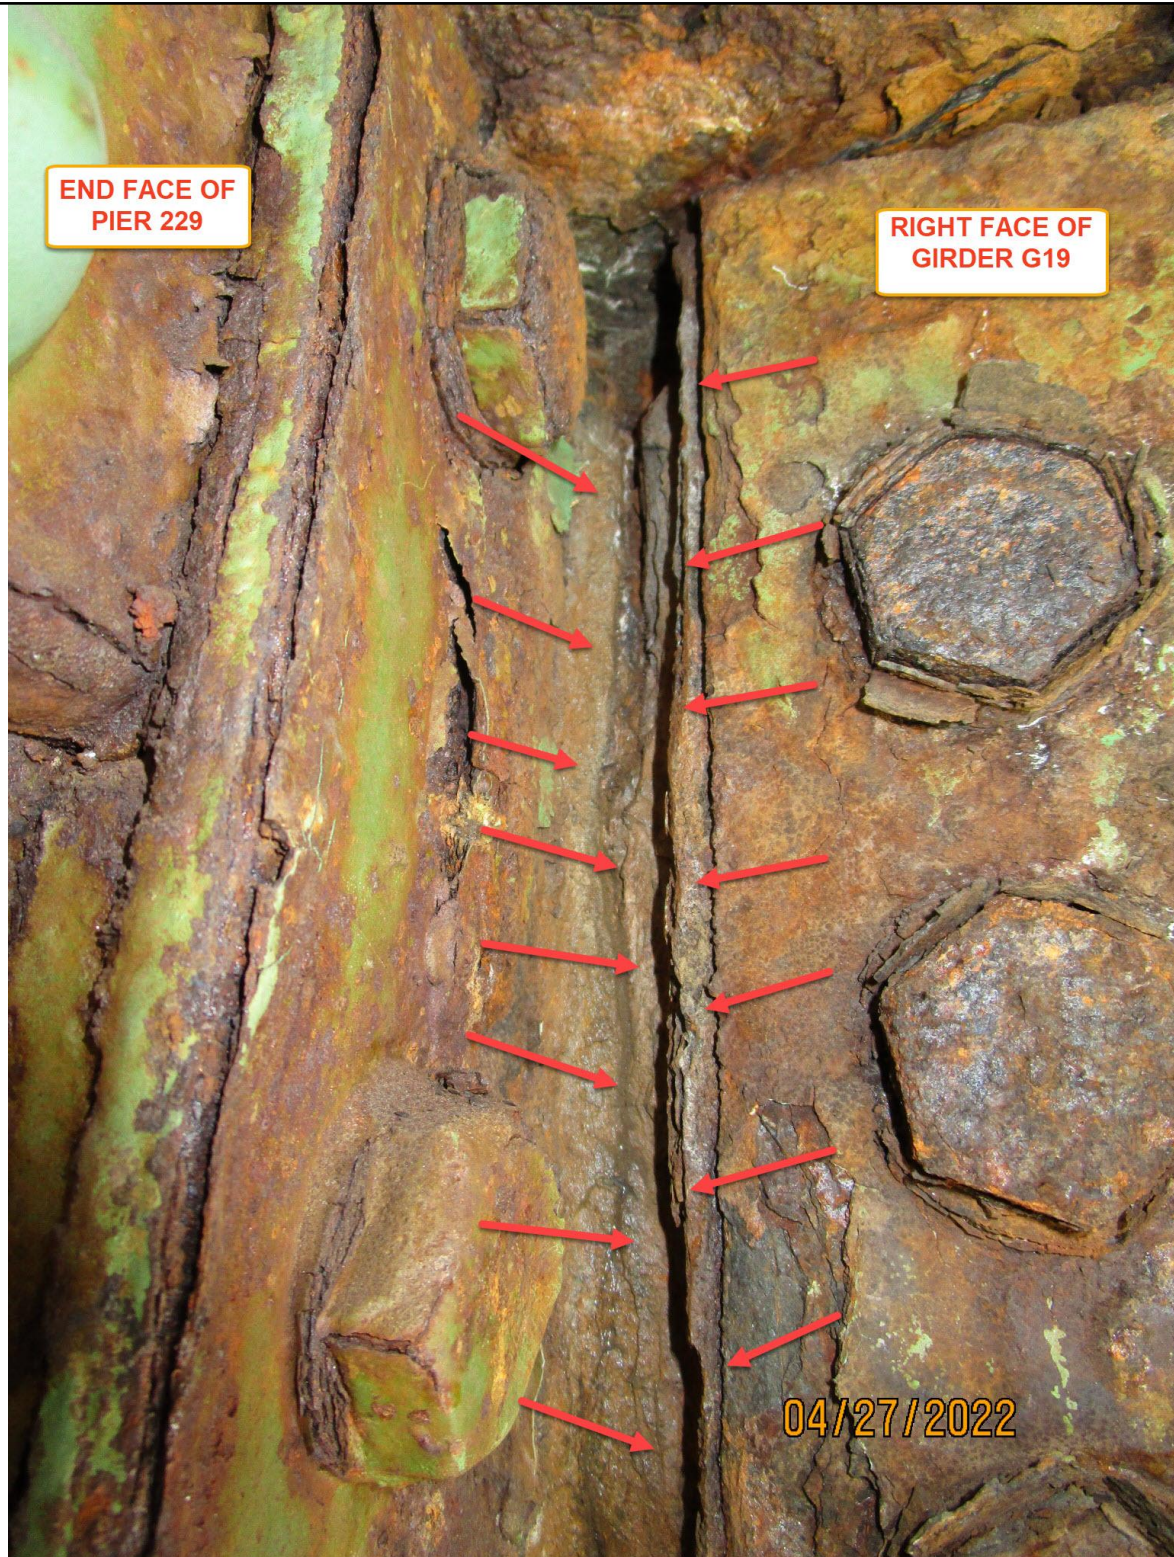
Photo Number: 4

Attachment Description: Span 230 Girder G19 at Pier 229: A vertical corrosion crack measuring 5" L x 1/4" W is located in the upper section of the right connection angle. Looking Left.

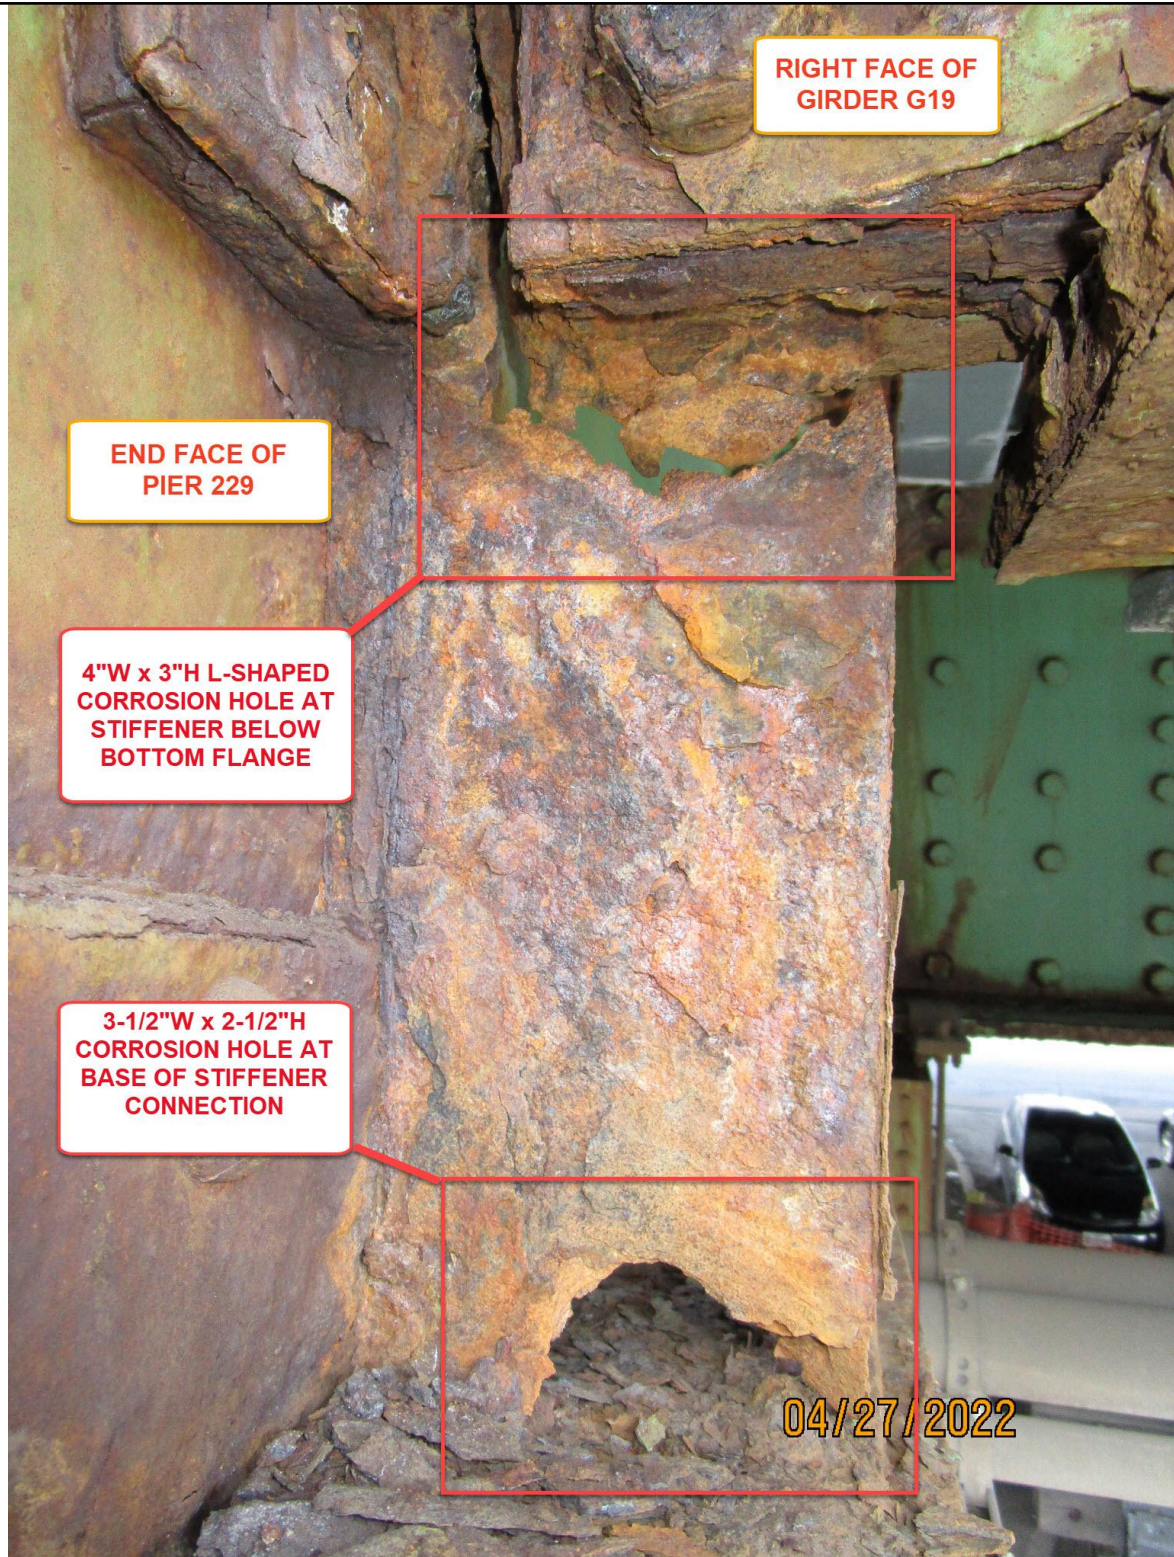
Photo Number: 5

Attachment Description: Span 230, Girder G19 at Pier 229: Two corrosion holes at stiffener connection angle with up to 50% section loss in surrounding area. Looking Left.

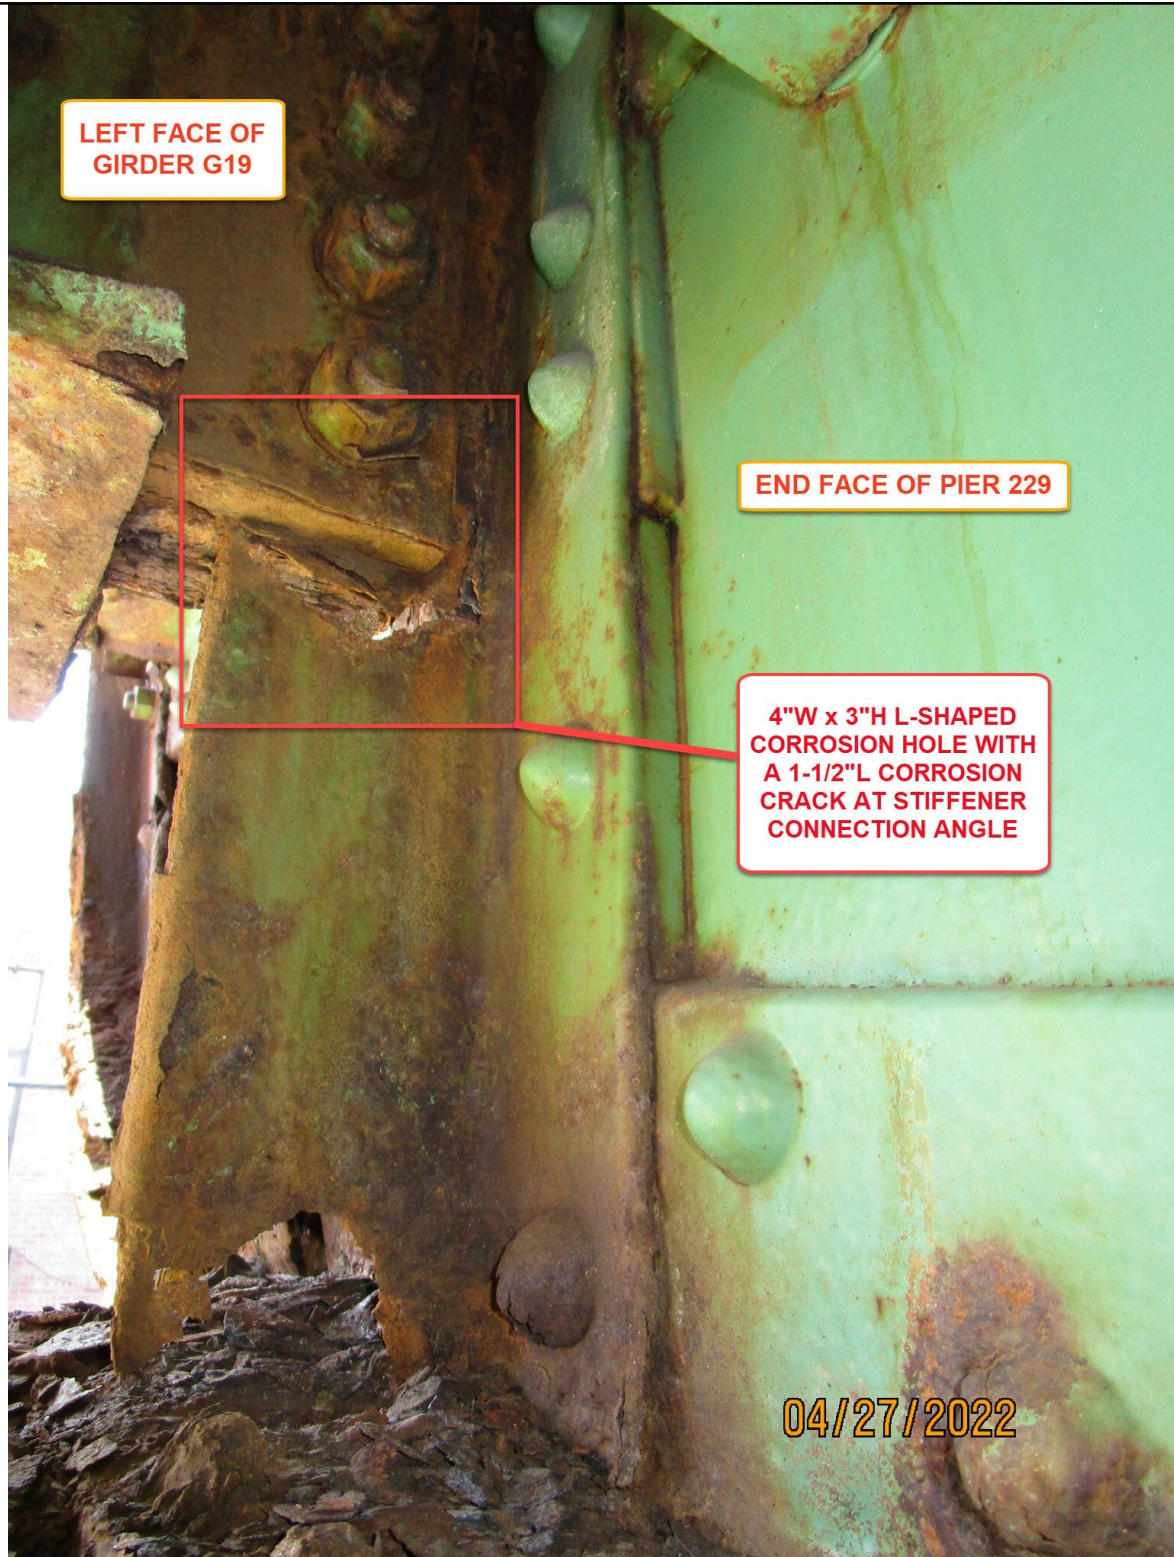
Photo Number: 6

Attachment Description: Span 230, Girder G19 at Pier 229: A 4"W x 3"H L-shaped corrosion hole located at stiffener connection angle with a 1-1/2"L corrosion crack and up to 50% section loss in surrounding area. Looking Right.

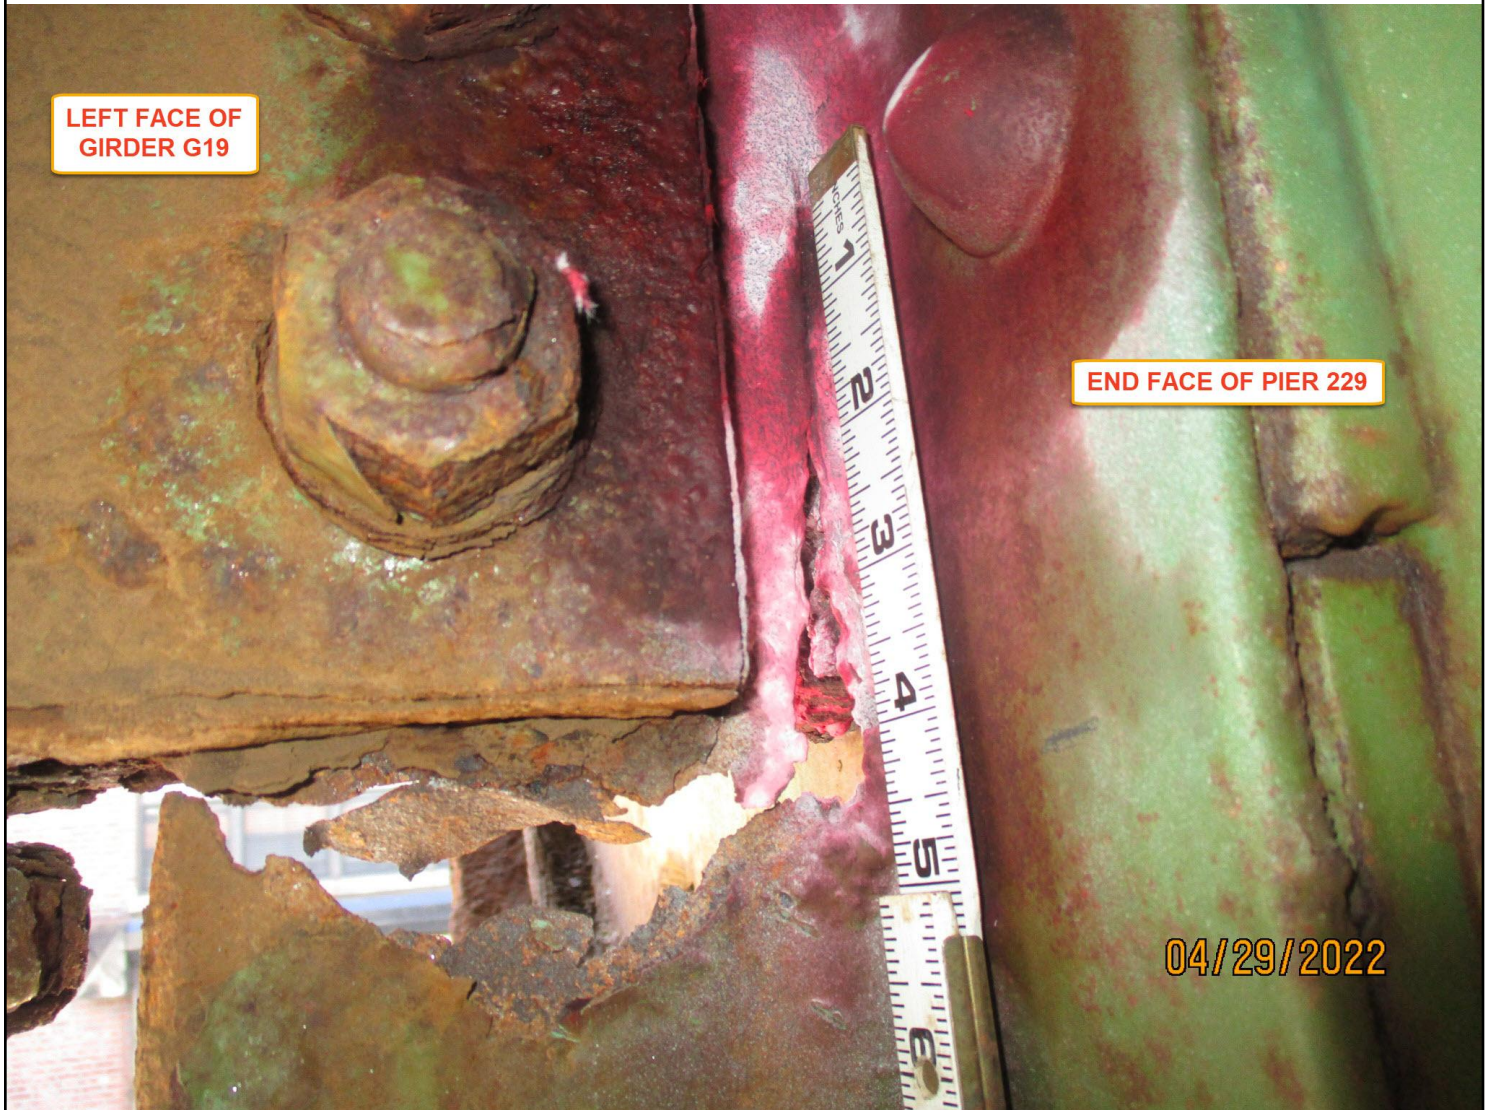
Photo Number: 7

Attachment Description: Span 230, Girder G19 at Pier 229: Close-up view of the 4"W x 3"H L-shaped corrosion hole located at stiffener connection angle with 1-1/2" corrosion crack, and up to 50% section loss in surrounding area, after a dye penetrant test. Looking Right.
